SEATTLE CITY LIGHT WORK ORDER #89-6
1989 MONITORING OF THE GEORGETOWN FLUME
(*Winter Flume*)

SEATTLE CITY LIGHT WORK ORDER #89-6
1989 MONITORING OF THE GEORGETOWN FLUME

SCL GEORGETOWN FLUME SYSTEM
WINTER TESTING - 1989

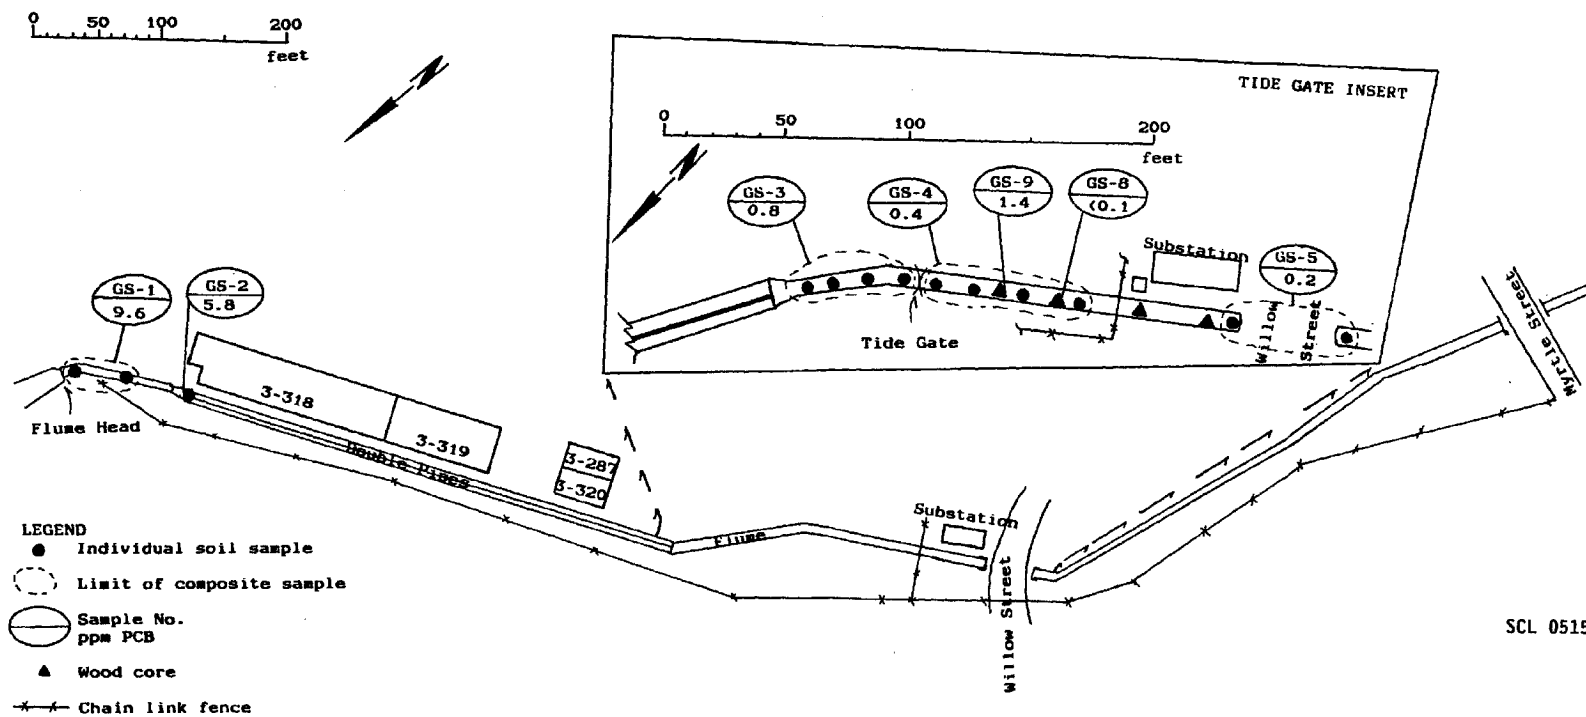
Figure 3

Wood cores were specified for this project. Raven has devised a corer that can sample any of the wood floor locations. The corer consists of a steel punch, 5/8" in diameter and nine feet long. Threads at the bottom of the punch allowed the corer to be screwed out from the planks after it had been hammered in. A slot was cut 2-1/2 inches above the bottom of the core nose to facilitate sample removal. The device resembles a giant leather punch. Sampling locations are shown in the Figure.

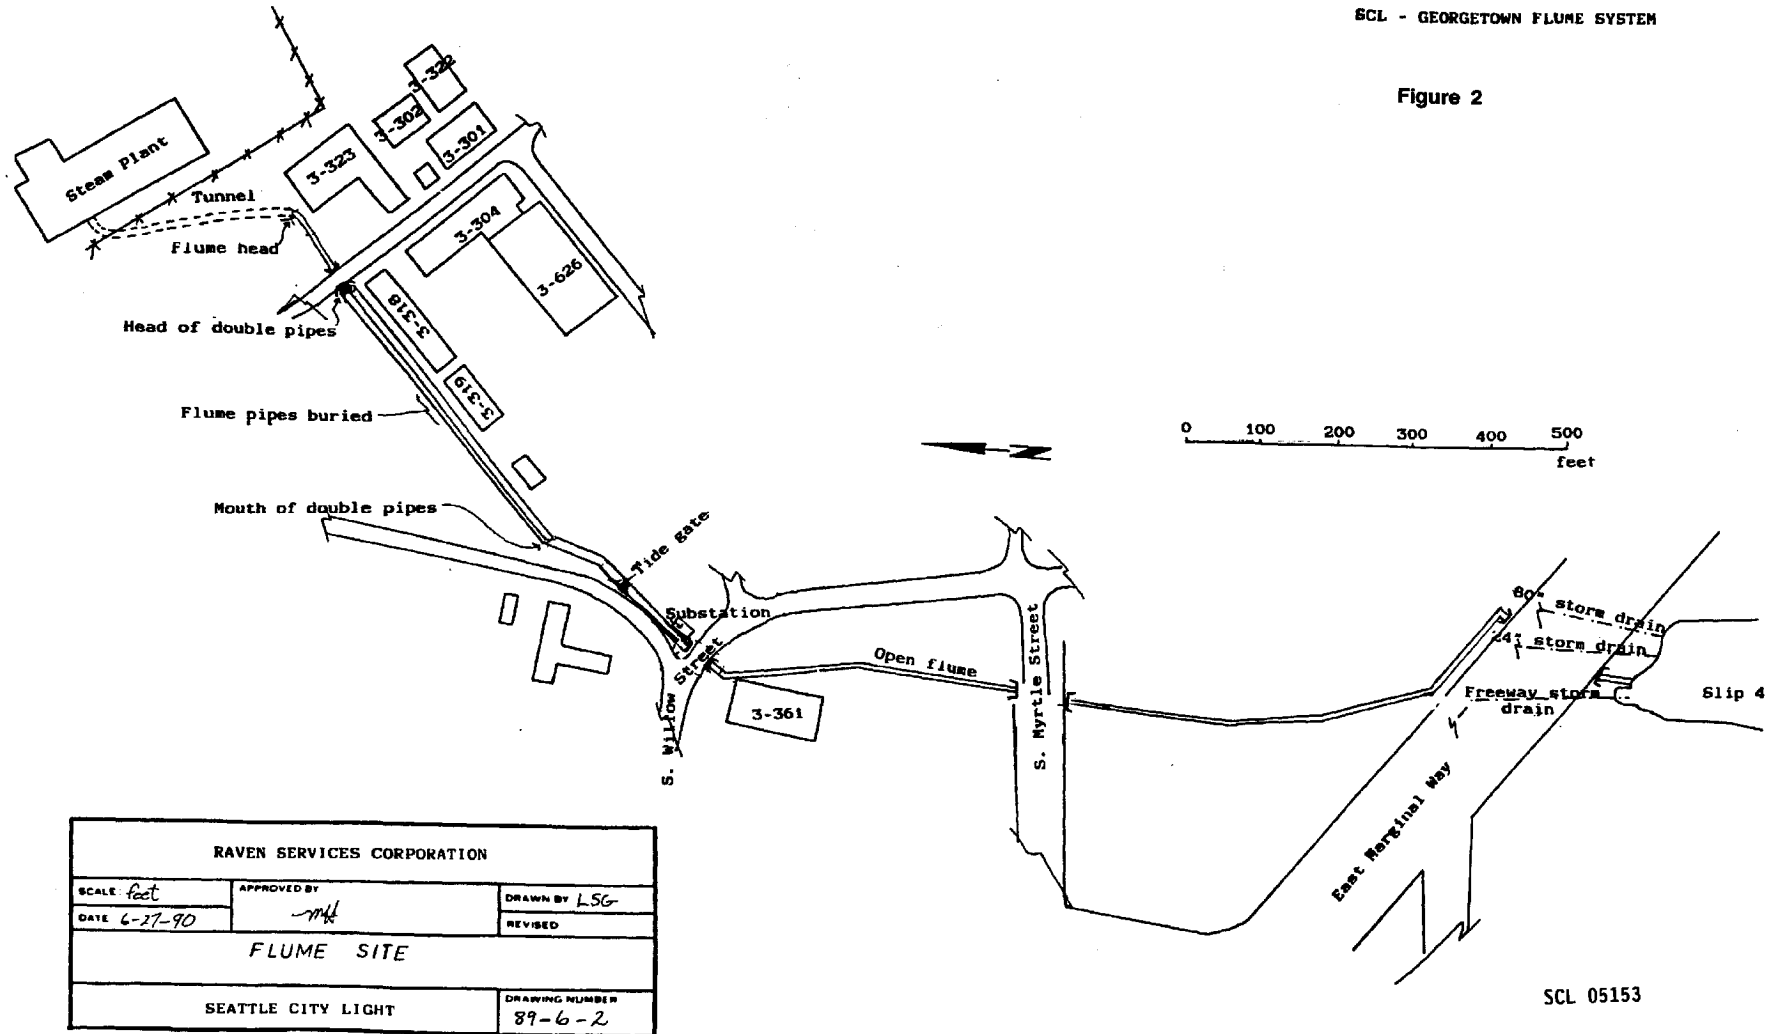
Figure 2

SCL - GEORGETOWN FLUME SYSTEM
